# Good Building Design - water appliances

**Water safety in hospitals**

**Sted: Oslo universitetssykehus, Ullevål**

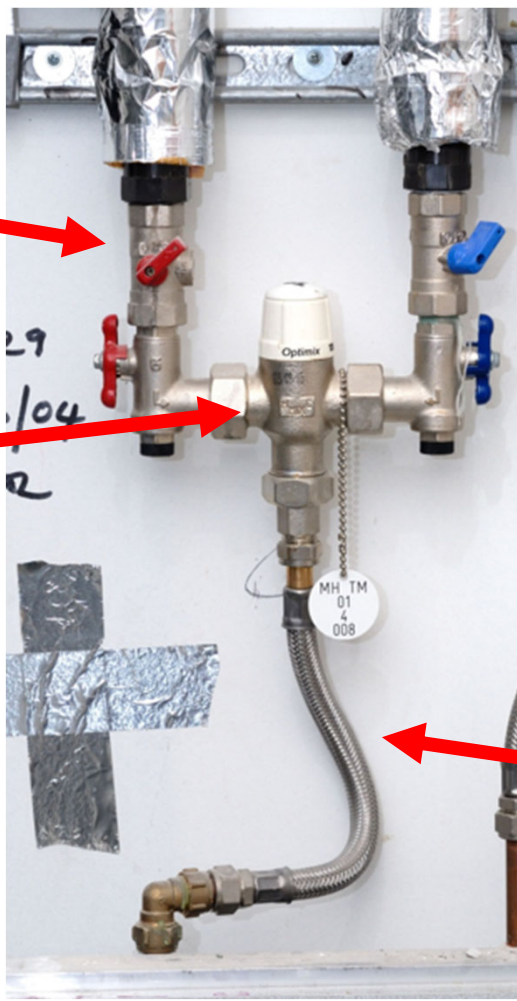
**HOT**

**COLD**

**THERMOSTATIC  
MIXER VALVE  
(TMV)**

**FLEXIBLE HOSE  
- SYNTHETIC  
MATERIAL  
EPDM**

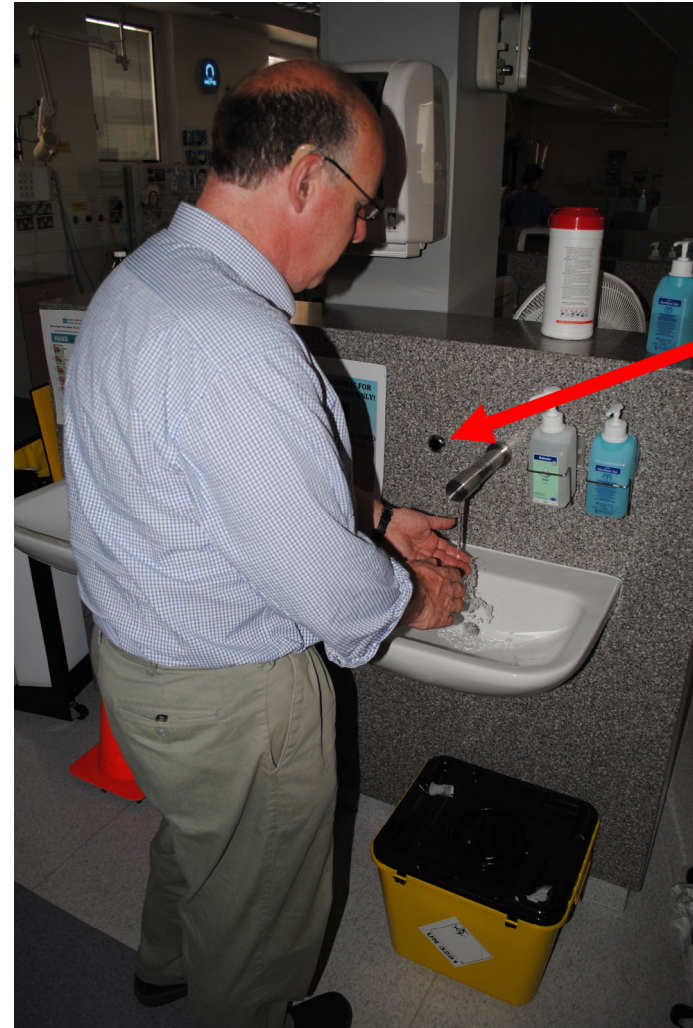
## Sensor Operated Outlet

**SOLENOID**

**SENSOR**

**HOT**

**COLD**

**THERMOSTATIC  
MIXER VALVE  
(TMV)**

**FLEXIBLE  
HOSES  
SYNTHETIC  
MATERIAL  
EPDM**

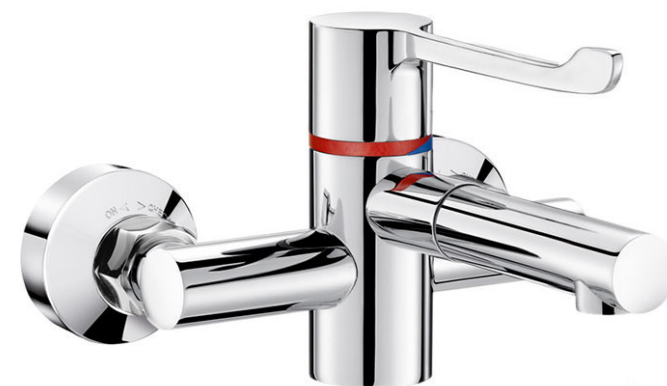
**Thumb operation to  
switch on**

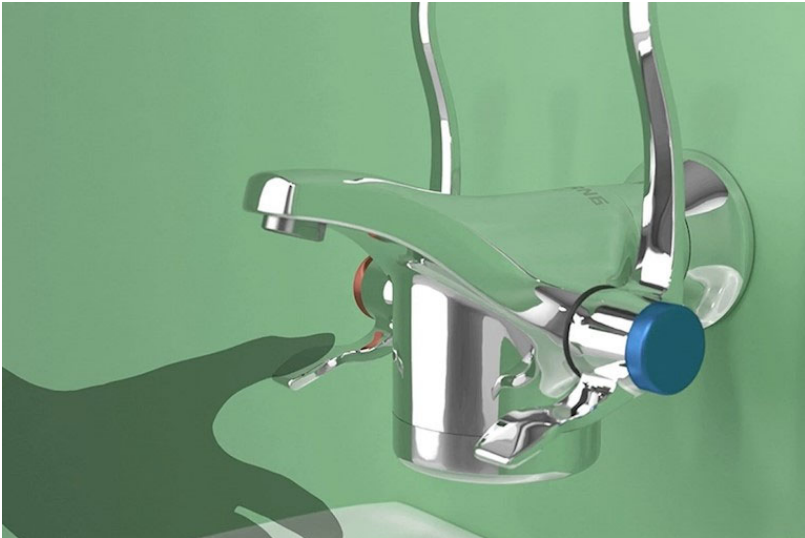
**Elbow operation to  
switch off**

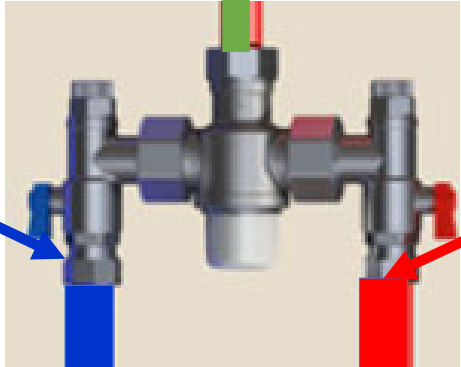
Mixed Outlet

**COLD  
INLET**

**HOT  
INLET**

**Thermostatic mixer valve**

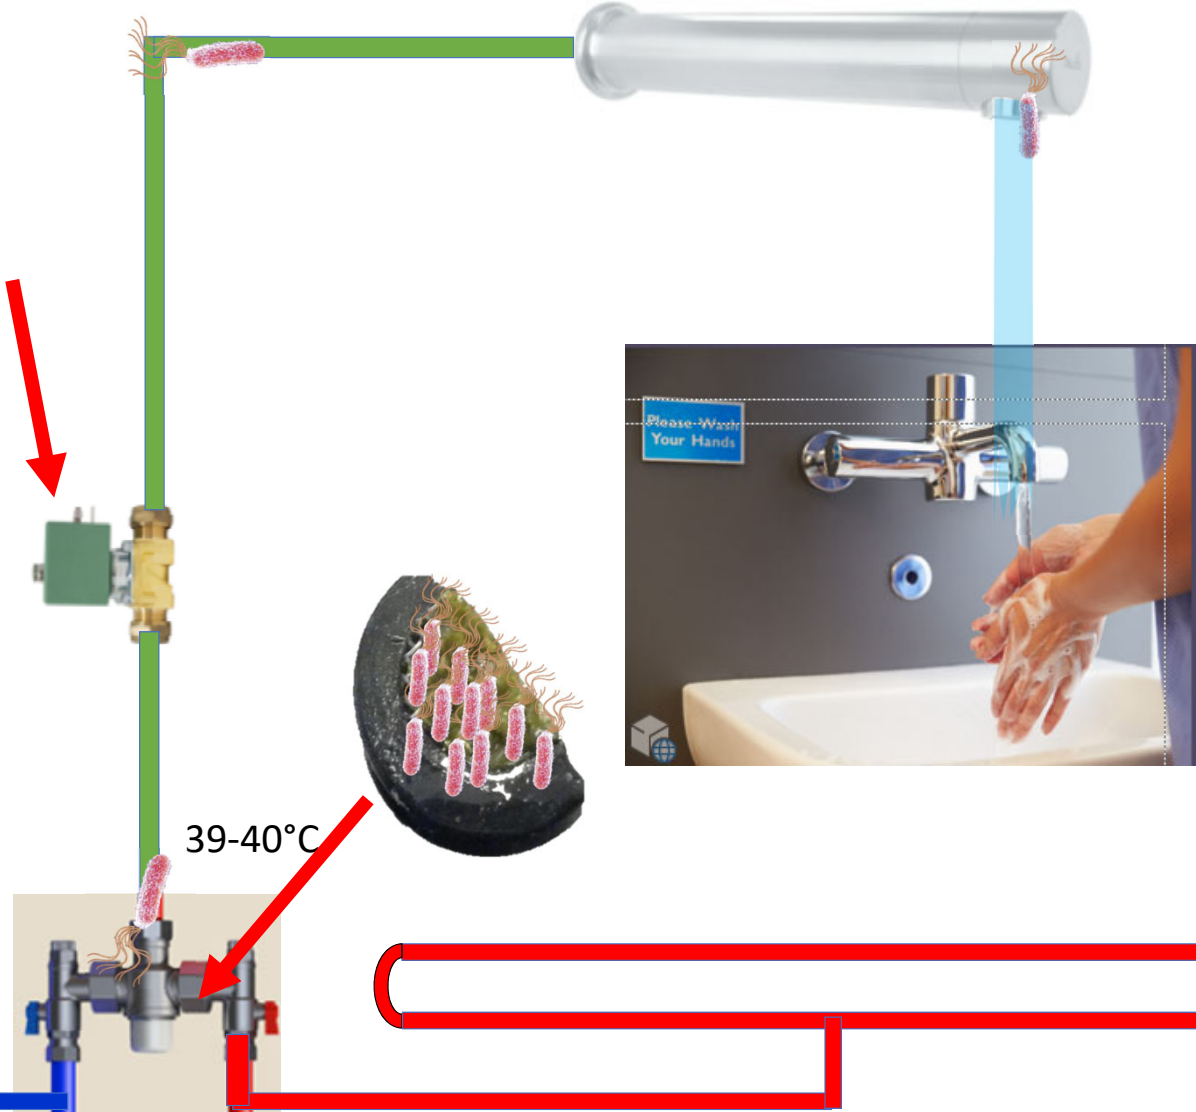
**Solenoid**

**4% Pa  
Positive**

**Thermostatic  
mixer valve**

39-40°C

20°C

55°C

60°C

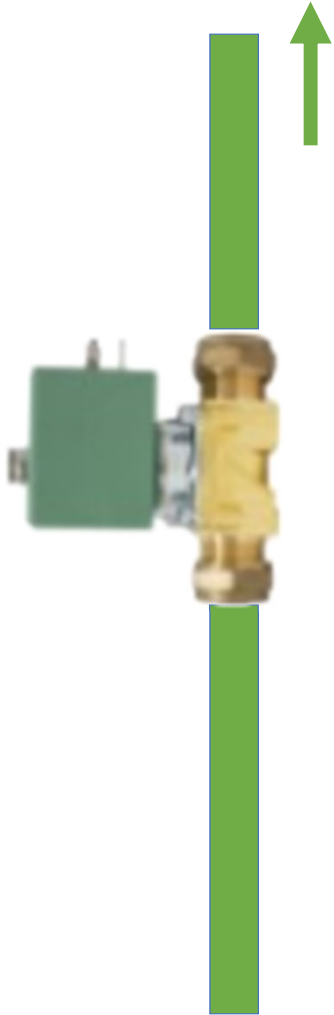
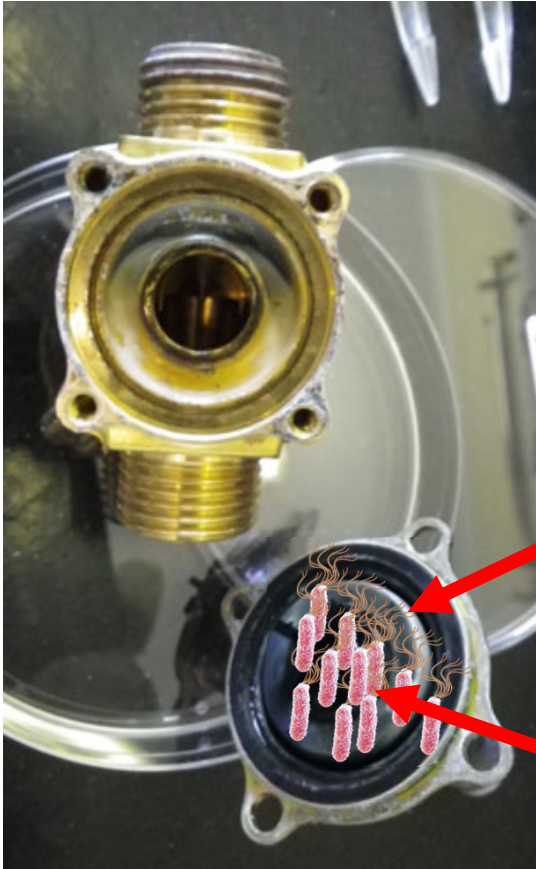
# Solenoid Valve

EPDM  
SYNTHETIC  
DIAPHRAGM

Biofilm

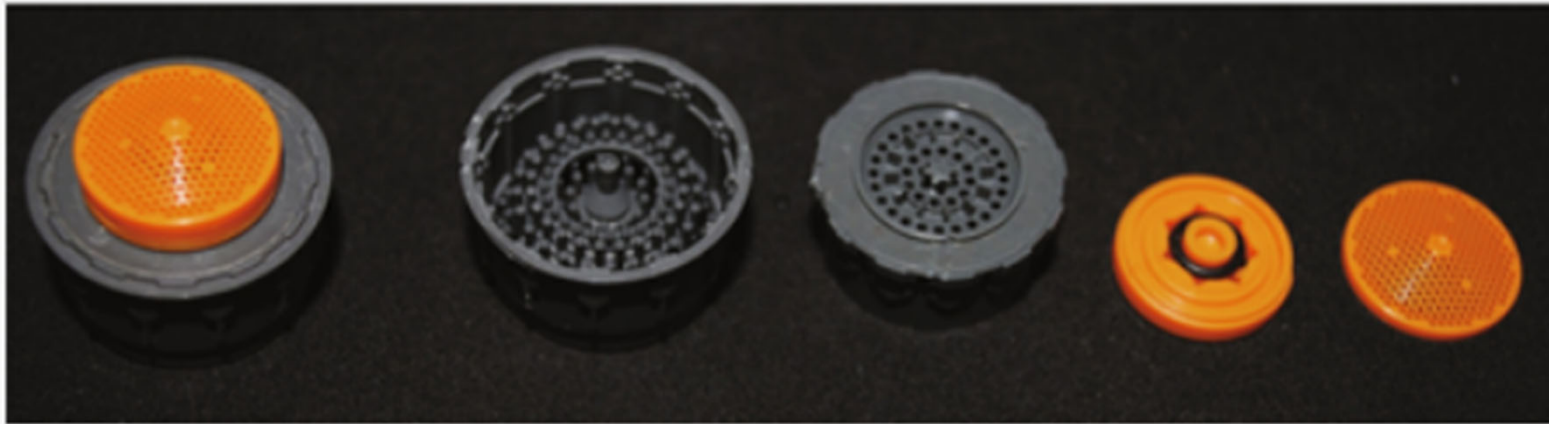
Aerators or flow regulators are used to reduce the volume of water used by mixing air with the water. However, they are inherently complex and present a high surface area to volume ratio that enable bacteria to colonize the surfaces. This image presents the large number of complex components that form an aerator.

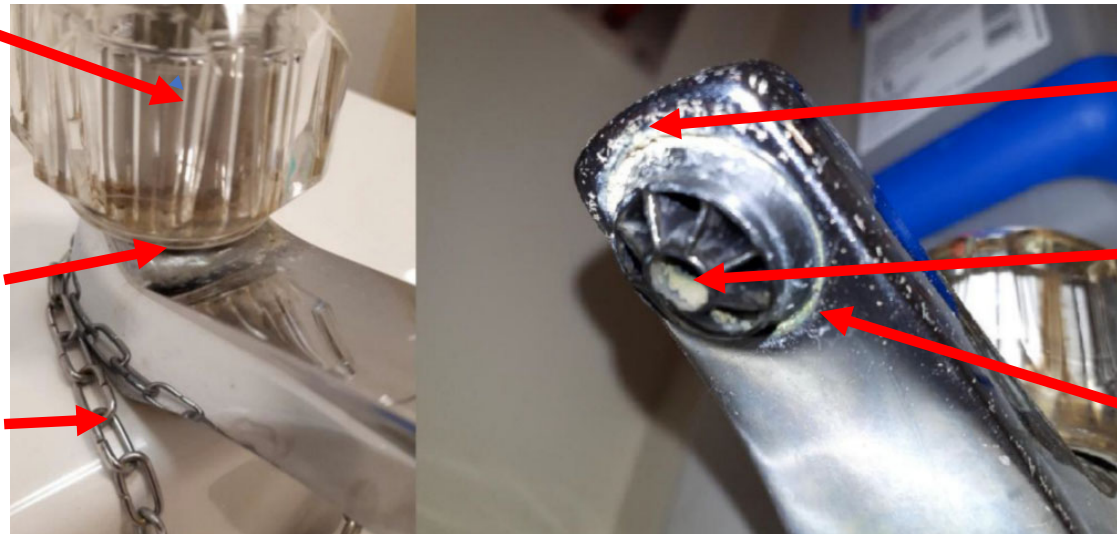
Lime scale that would harbour bacteria

Difficult to clean outlet

Crevices and niches in which bacteria would be protected

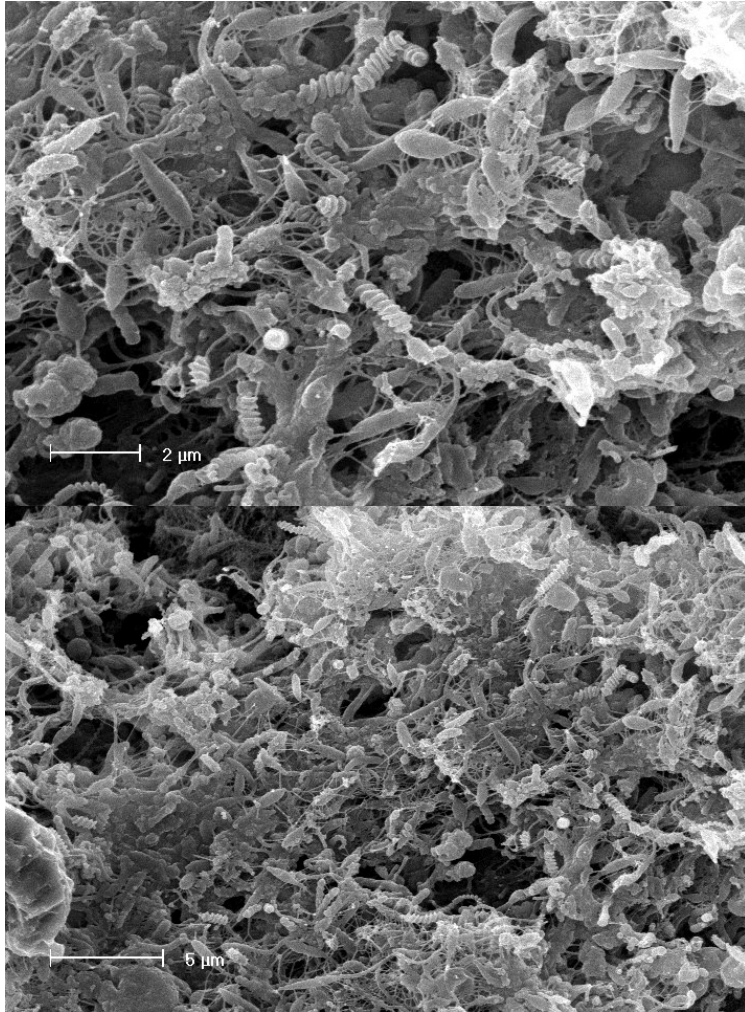
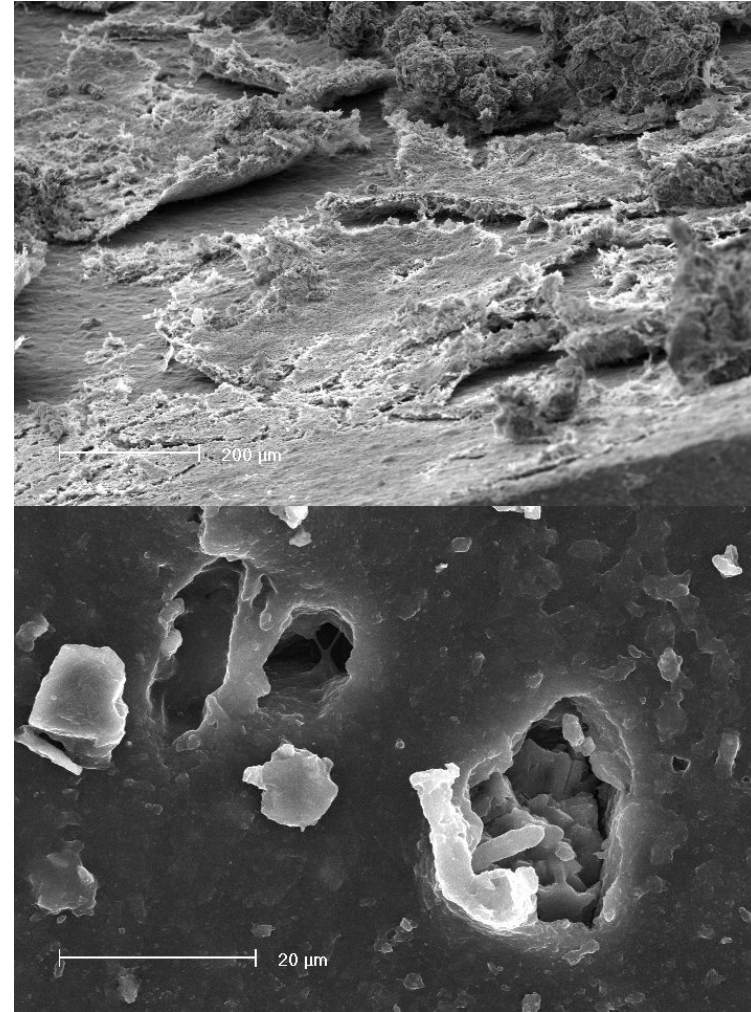
# Biofilms in lumen of flexible hoses

(SEM with kind permission of Dr T Makin Sen)
